Westfjords Natural History Institute

**Study of mass movement processes
on slopes above man made structures
in the Westfjord area.**

Thomas CHAREYRON

August 2001

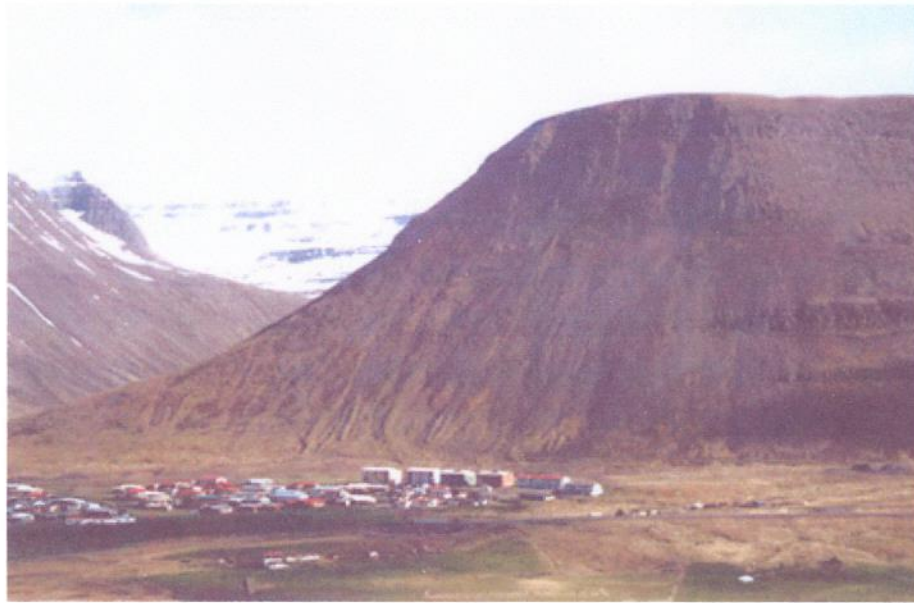
Figure 2: Overview of Kubbi and Holtahverfi. The slope is facing north.

The studied slope extends between Kubbi to the edge of the residential quarter. In the upper third of the slope, the bedrock appears and forms an irregular and eroded cliff with gullies (Fig. 1 & 2).

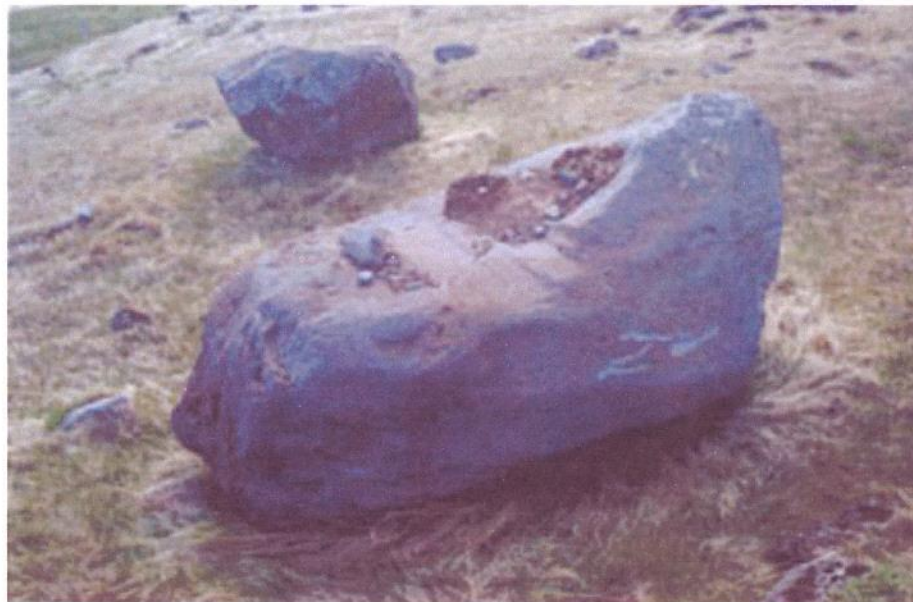
Figure 3: Fine grained deposits and scars on a remote large boulder put on the ground at the foot of the inner part of the Eyrarhlíð slope. The bigger boulder is about 2 m long. The picture is taken towards east. The Eyrarfjall mountain is on the right.

Northeastwards, the slope shows signs of much stronger erosion. The tracks 5 to 9 deeply cut the slope (see appendix, figure 26). They start from gullies dug in the bedrocks at the top of the Eyrarfjall mountain. The tracks are associated downhill with large colluviums. These colluviums coalesce each others, particularly 7 and 8. They are all covered by vegetation and have a fairly regular shape. Only small portions generally situated on the sides of the colluviums are not vegetated and dug by erosive channels. Scattered boulders and stones appear on the surface these colluviums and far downslope, down to the fjord. However most of them have been cleared in the lowest part if the slope as a result of development of roads, buildings and fields. Some finer deposits and sometimes scars can be observed on remote large boulders put on the ground surface (Fig. 3).

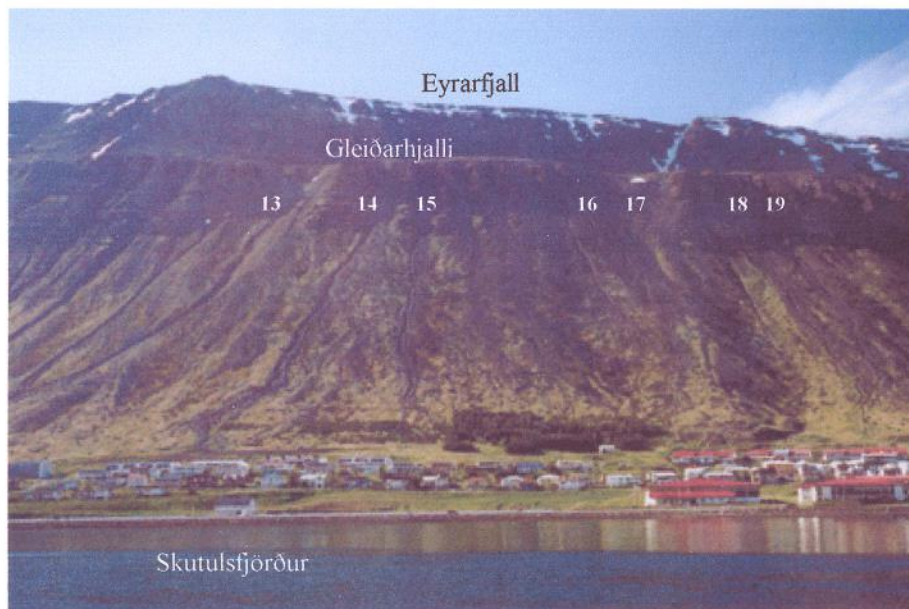
Figure 4: Overview of the inner part of the Eyrarhlíð slope interrupted by the Gleiðarhjalli plateau situated at about 450 m.a.s.l. In the background the top of the Eyrarfjall is at 724 m.a.s.l. Part of the Ísafjörður village lay along the fjord Skutulsfjörður. The picture is taken toward the northwest.

The slope of Eyrarhlíð is steep and is coming down from the levelled Eyrarfjall mountain (724 m.a.s.l.) and interrupted by the Gleiðarhjalli plateau (around 450 m.a.s.l.). See Fig. 1 & 4.

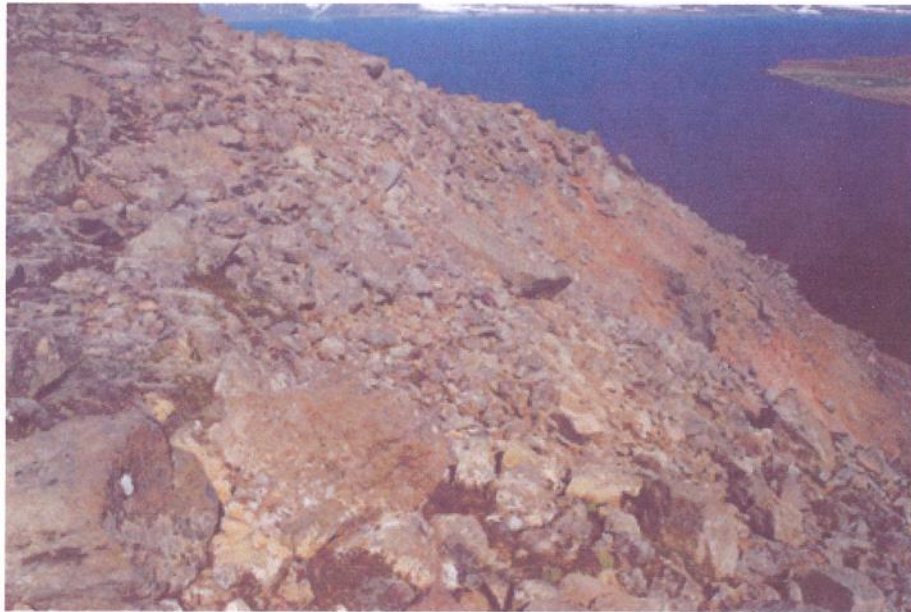
Figure 5: Debris covered source area 18, in limit of the Gleiðarhjalli plateau. The picture is taken toward northeast.

Numerous bowl-shaped source areas are cut into the edge of the plateau and covered by huge amount of loose and available material of all sizes, mainly instable sand and gravel covered by boulders (Fig. 5). In the most eroded parts, the boulders cover is manquant and boulders loosen due to erosion of the fine-grained matrix (Fig. 5). Under this source level, harder rockbed layers are thrown into relief but deeply dug by gullies beneath each source area, creating steep couloirs with striped ground

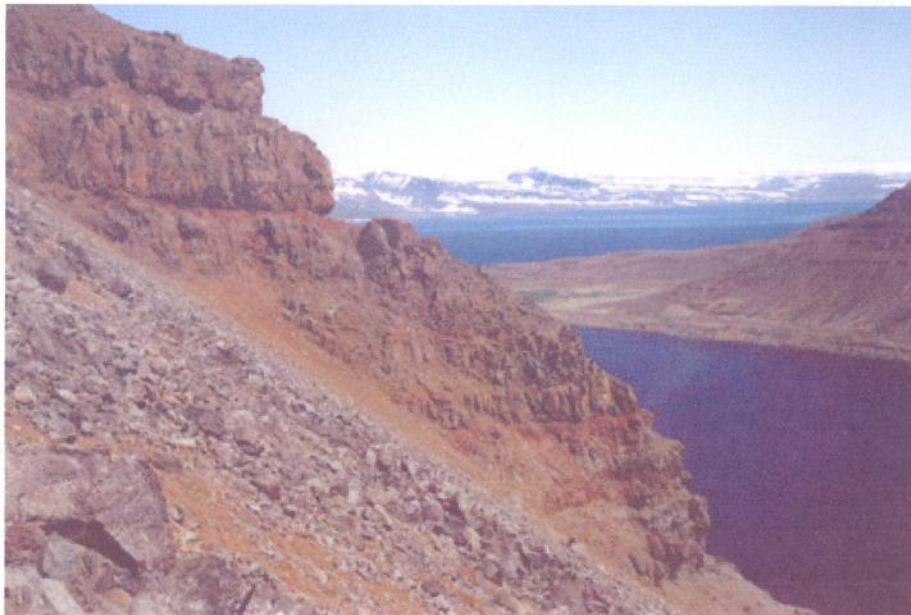
Figure 6: Escarpments presenting overhanging rocks, which result from erosion of the soft soil layers. The picture is taken from the gully 17, towards northeast.

and delimited on the sides by vertical walls. Some isolated instable rocks are present. The erosion of the relatively narrow soft soil beds leads to overhanging ends of rockbeds layers (Fig. 6).

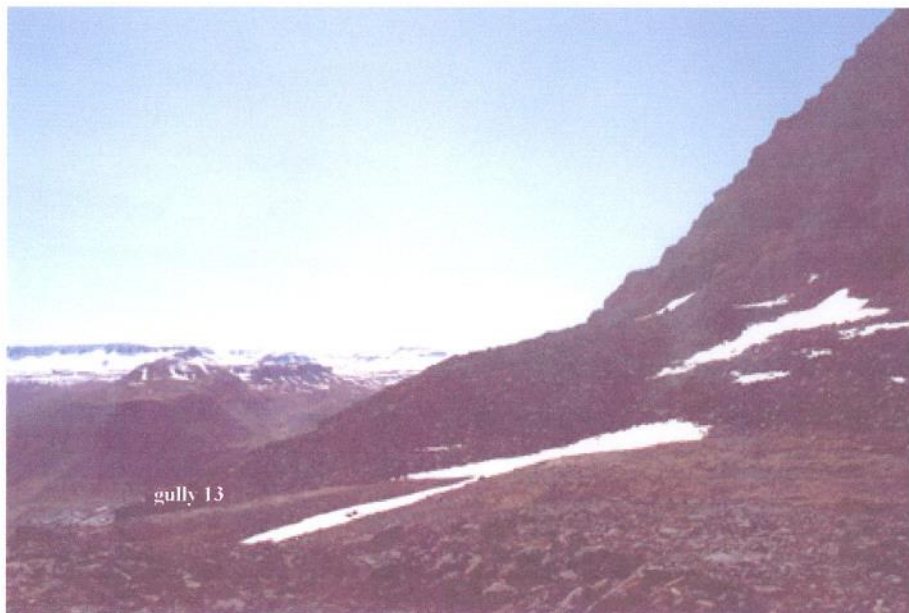
Figure 7: Western end of the Gleiðarhjalli plateau. Debris from the upper cliff extend down to the down slope limit of the plateau and can therefore be involved by landslides in the lower part of the slope by regressive erosion. The picture is taken towards southwest.

On the sides of the plateau, where it is the narrowest, scree from this cliffs reach the edge of the plateau (particularly the gullies 10 to 13) and are about to be involved again by landslides in the lower part of the slope due regressive erosion into the plateau, supplying important amount of large boulders (Fig. 7).

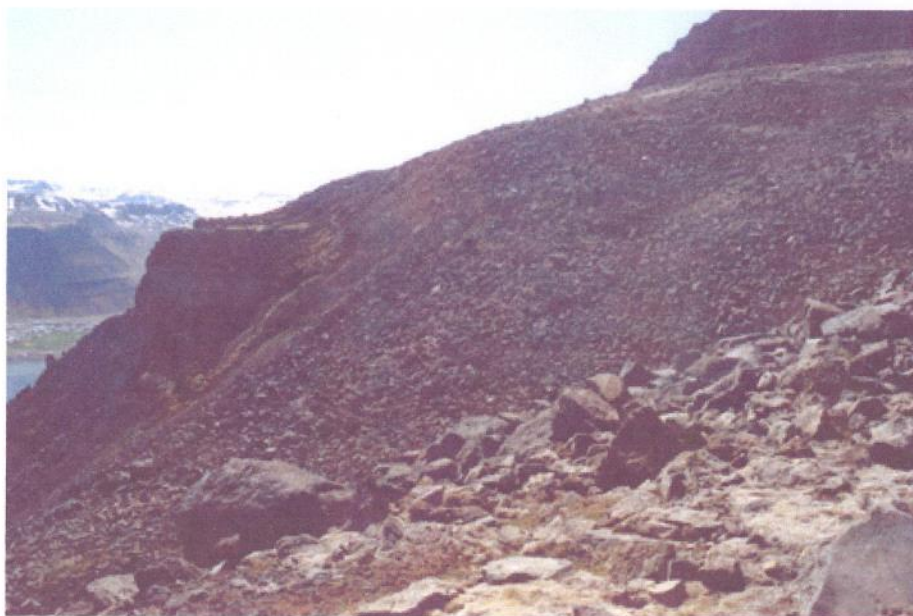
Figure 9: Source area of the gully 17 at the limit of the Gleidarhjalli plateau. A large amount of boulders is present. The picture is taken toward southwest.

Centrally the wide gully 17 dominates a slope covered by scree (Fig. 9), often of large size (boulders), all the way to the foot of the slope and therefore creating a small hill with a steep front. On the western side, there are some channels but they don't originate from the same gully and look small compared to the quantity of the debris present.

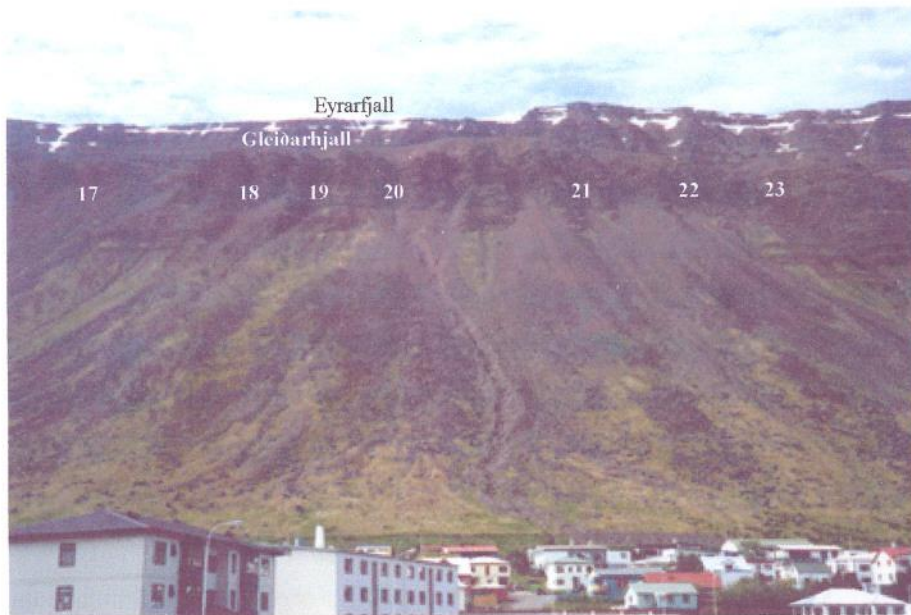
Figure 10: Overview of the outer part of the Eyrarhlíð slope. The picture is taken towards northwest.

Then, northeastwards, the slope is quite similar that it was west of the gully 17 with a good proportion of vegetation-covered areas (Fig. 10). Large boulders are accumulated in some parts. The channel 20, with nice levées, reaches a shield protecting the houses (Fig. 10 & 11). Scattered boulders sprawl at the foot of the slope. One is encased in a print hollow.

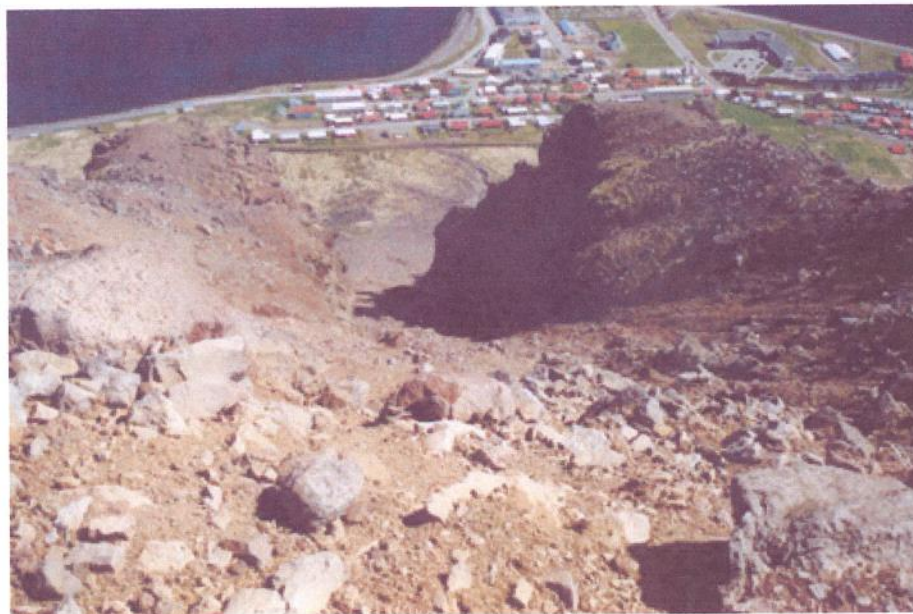
Figure 11: Source area and deep gully on the top of the lower part of the slope Eyrarhlíð. One can see the channel that reaches the shield along the upper houses of Ísafjörður. The picture is taken towards southeast.

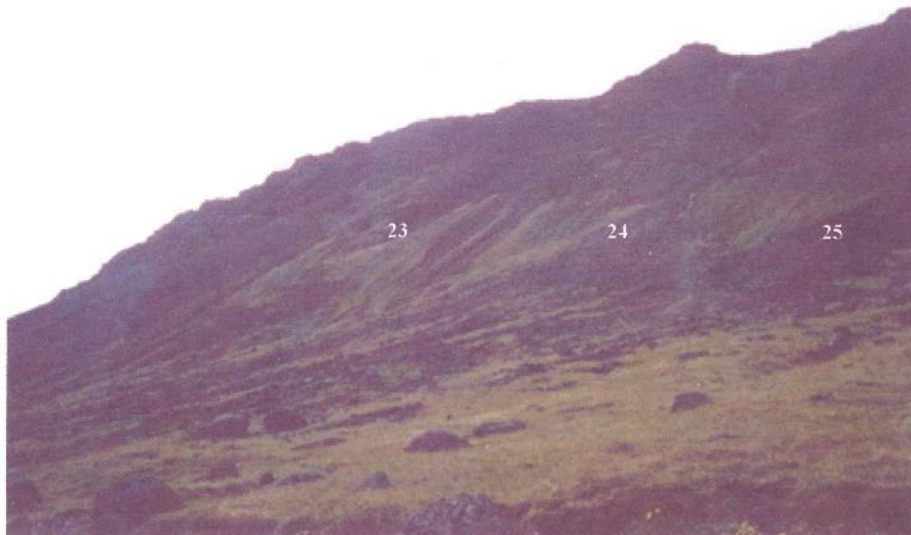
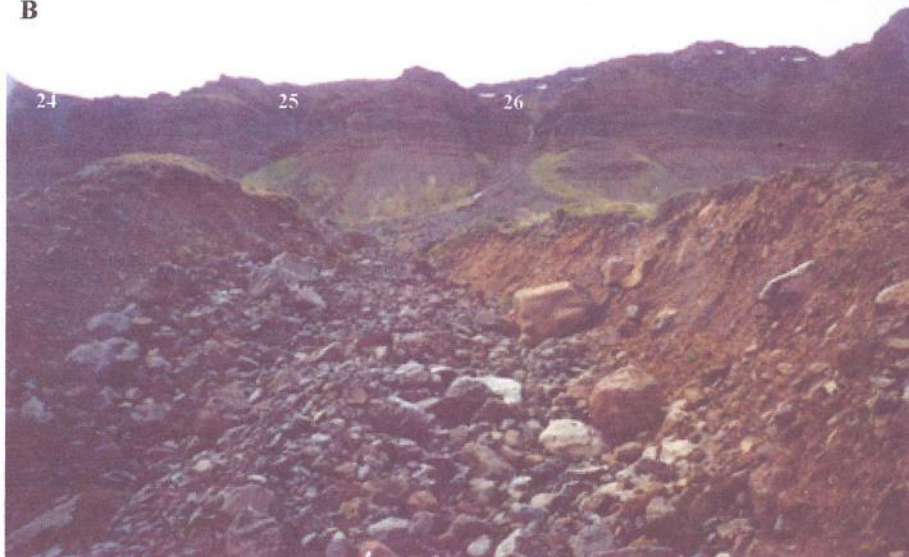
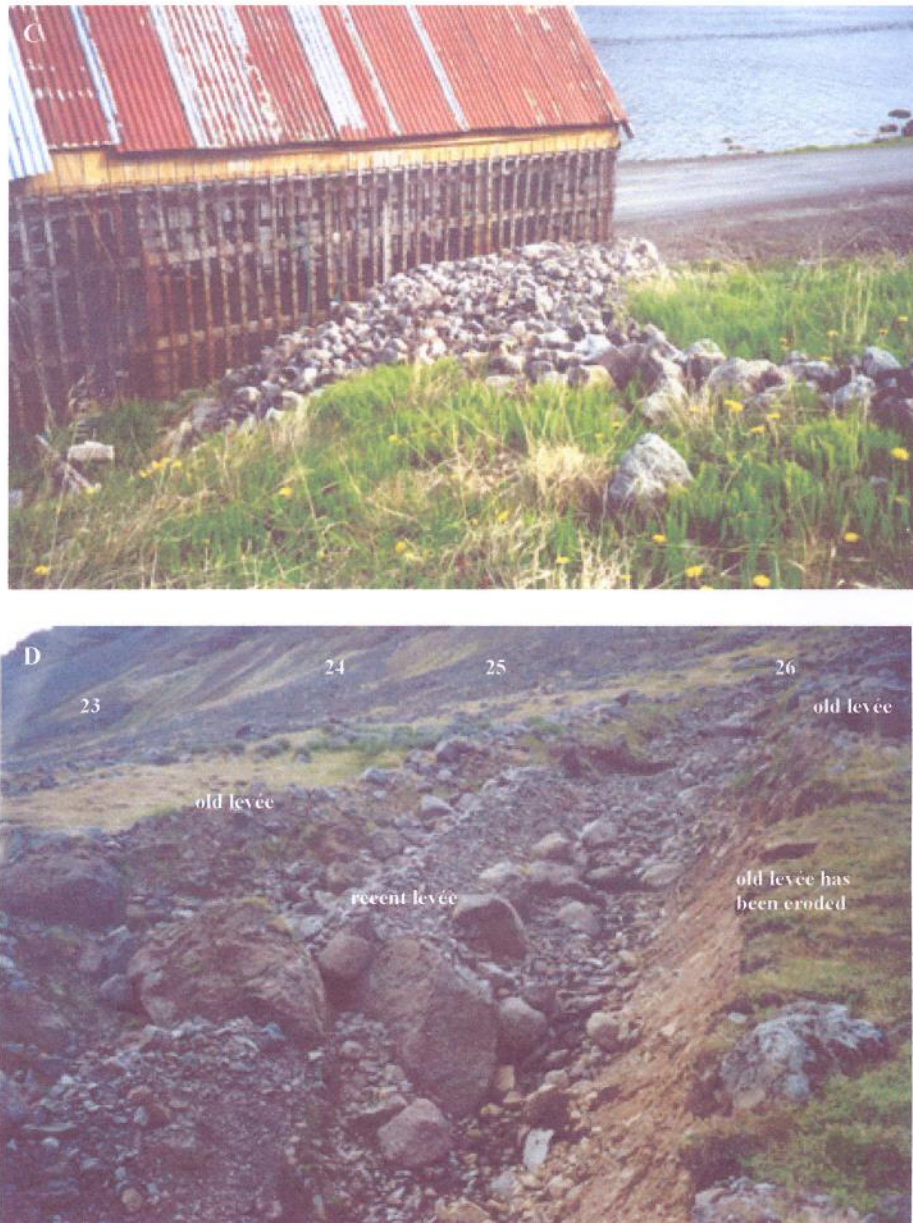
Figure 12: (A) Different morphological aspects between the convex upwards fan 23 and one of the concave upwards fans (24); (B) Large channel (4 m wide) below the fourth colluvium 26; (C) Levées which had reached the road and a building downstream of the colluvium 26. The lower end of the roof is at about 2 m above the initial ground surface level and 50 cm above the new surface; (D) Several successive channels along the same track 26. The two large boulders are about 2 m long.

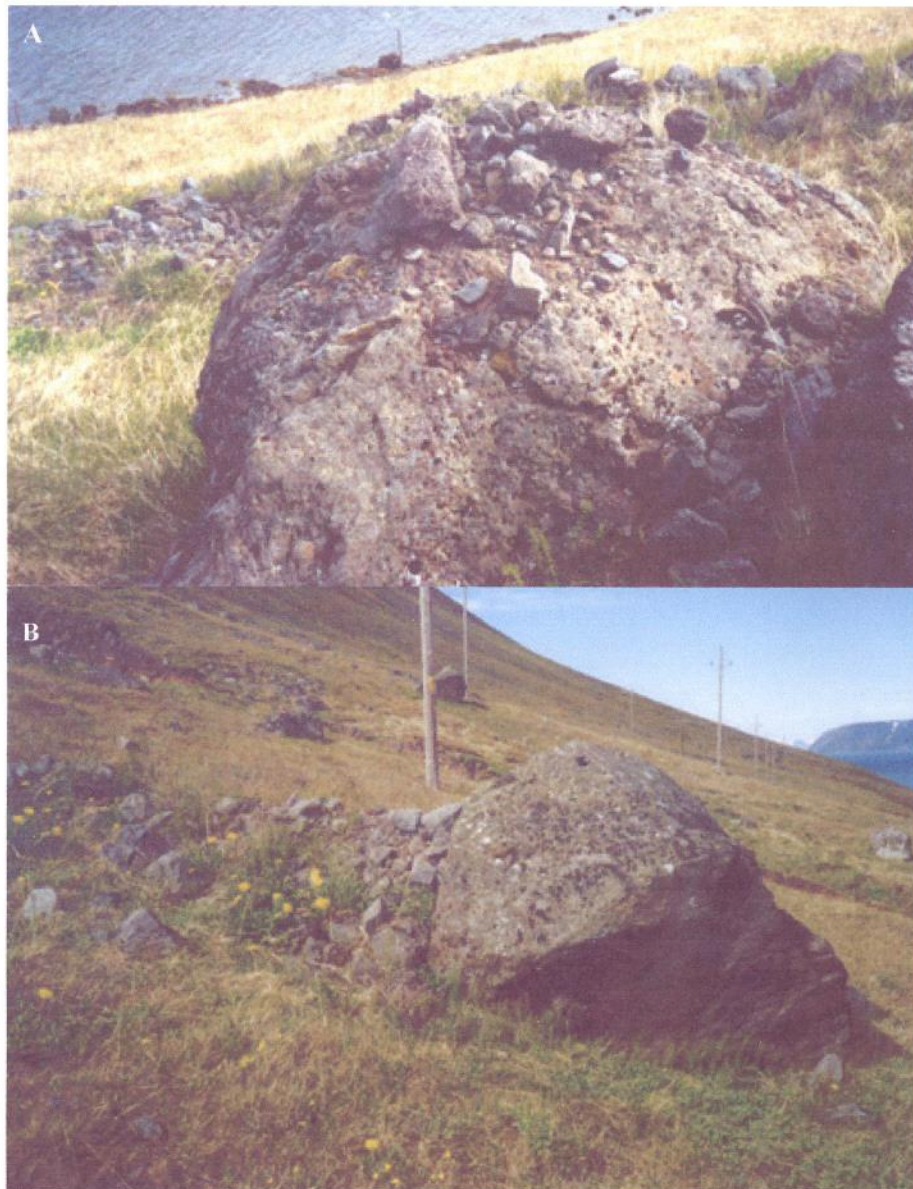
Figure 13: (A) Boulder on the ground and covered by finer debris, between the tracks 25 and 26; (B) "Debris horn" above of a boulder. On the two pictures, the photo film box on top of the boulder is 5 cm long.

A large number of scattered boulders, sometimes very big, occur all the way down, even to the fjord water in the axis of the small gullies. However these boulders are more dispersed especially as the distance from the source area increases. Smaller debris lie on some of the boulders and some boulders present scars. A triangular deposit of debris “debris horn” lies above a small boulder (Fig. 13 A & B).

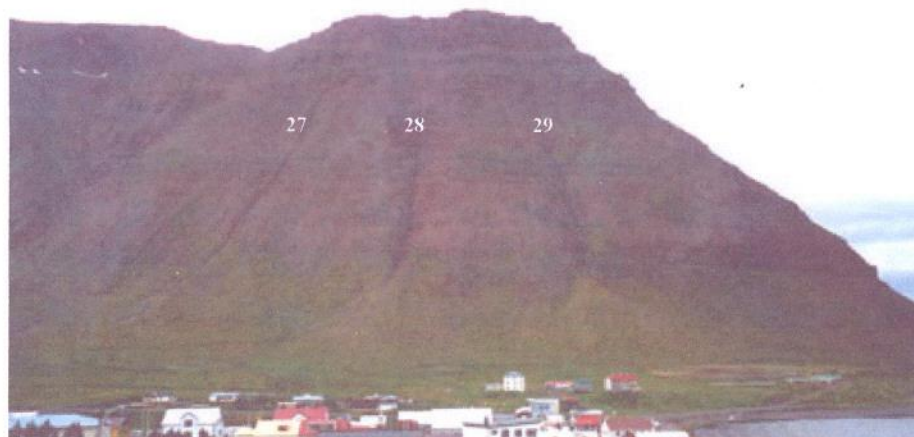
Figure 14: Overview of the south-facing slope above Hnífsdalur. The top of the mountain is at an altitude of 647 meters and the sea appears in the right-low corner.

The slope is regular and with three elongated tracks each opening on a colluvium (Fig. 14).

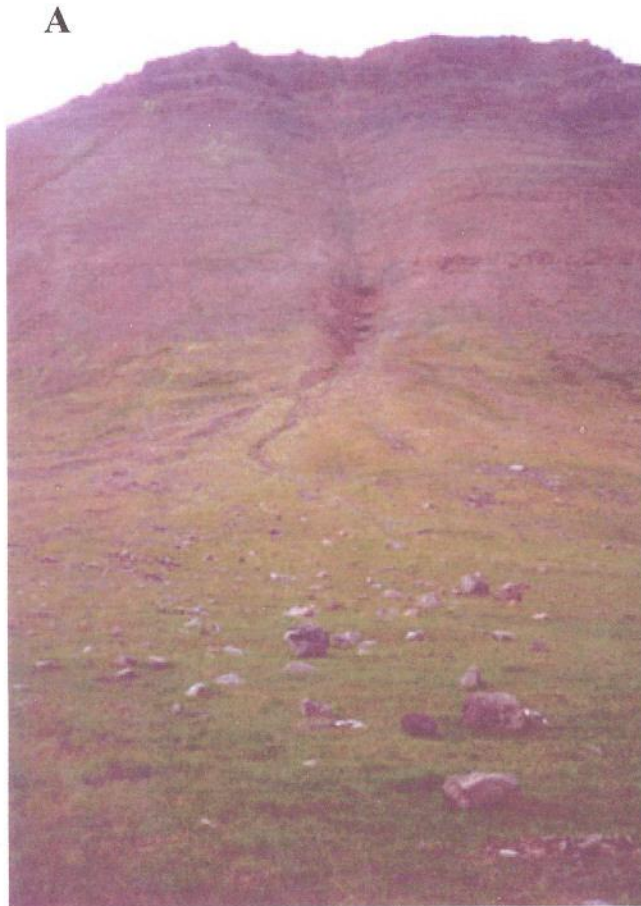
Figure 15: Colluvium 28 in Hnífsdalur (A) Track and smooth colluvium with stones on the surface.

The second colluvium is much bigger and extends much further down. It is at the opening of a long V-shaped track (Fig. 15A). It is relatively regular, smooth but surface shows undulations, which are traces of old debris flow channels. The colluvium is well vegetated but bare with stones on the higher parts. No boulder is present on the colluvium but they are numerous and relatively small downhill (Fig. 15A). Some small debris (stones, gravel) is also there. In the proximal part but along the outer limit, a boulder presents debris its upper faces (Fig. 15 B & C). In the centre, one of the channel is clearly more recent than others but not very recent (presence of vegetation, faded out relief).

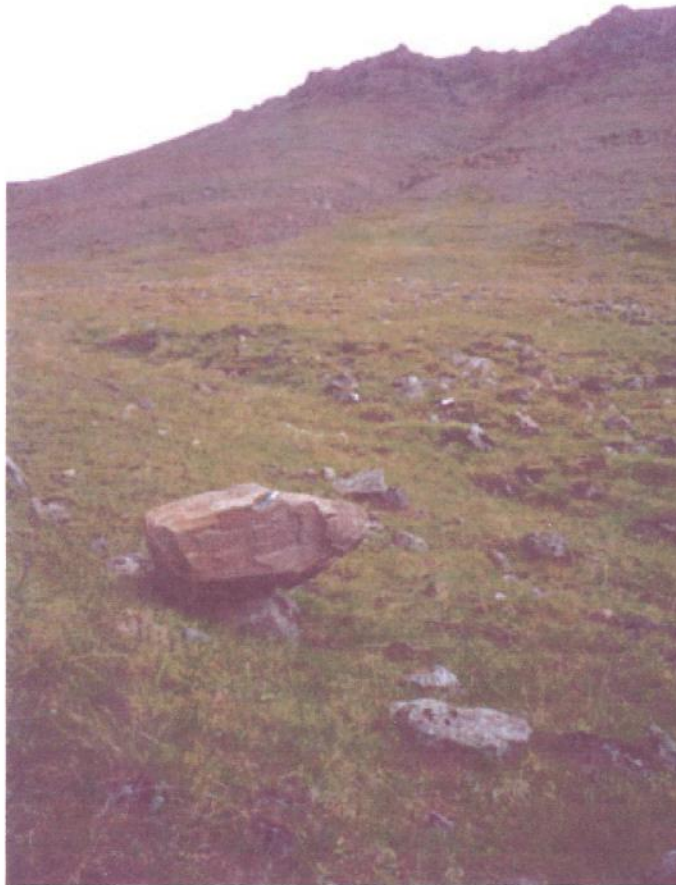
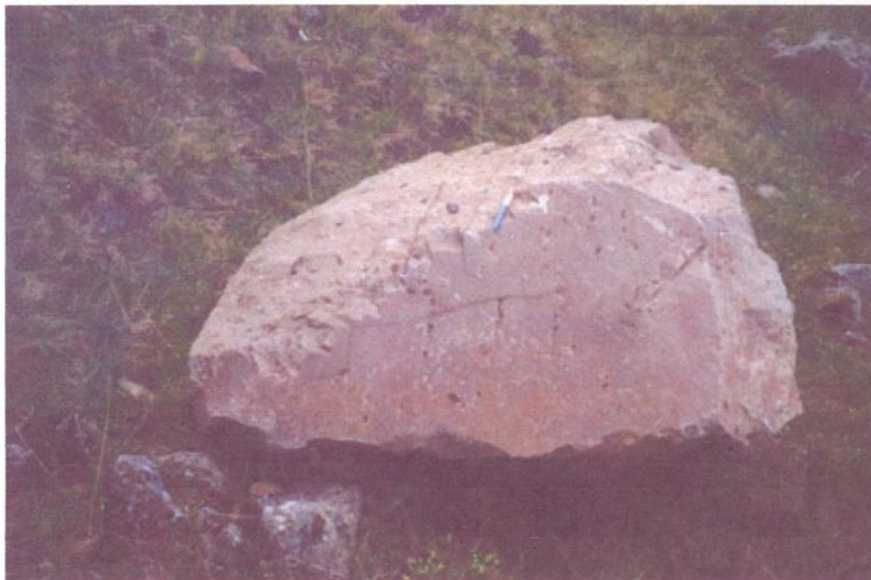
Figure 16, cont.: (B) Boulder along the outer limit. Pen for scale; (C) Close-up of the same boulder. Finer debris lay on its upper surfaces. Pen for scale.

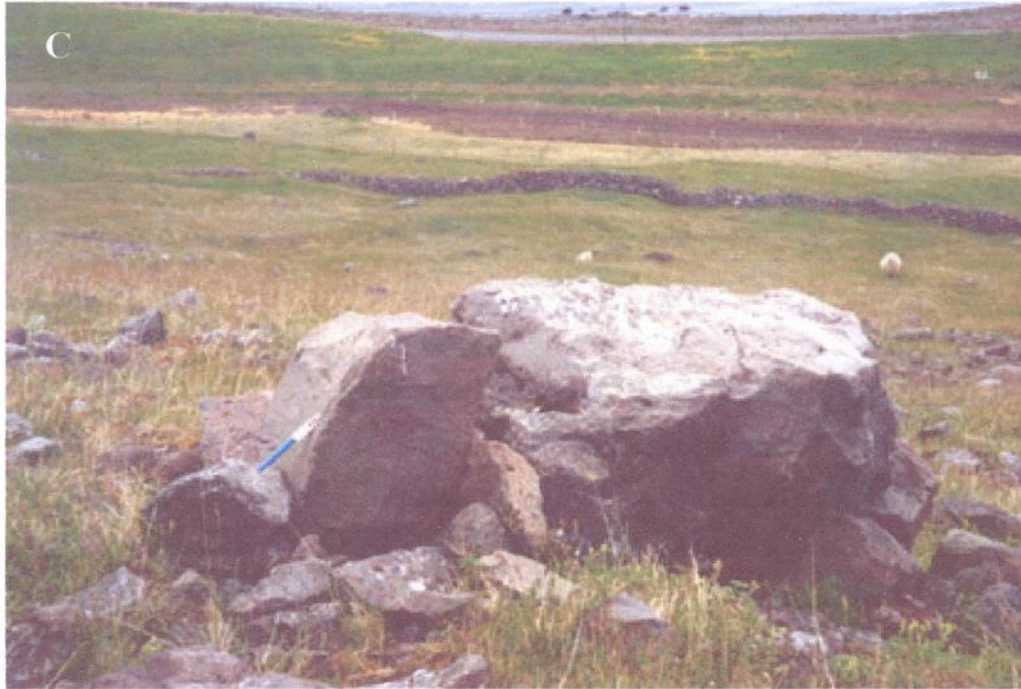
Figure 18, cont.: Colluvium 29 in Hnífsdalur; (C) “Debris horn” situated in the area of the colluvium presenting traces of channels. Pen for scale.

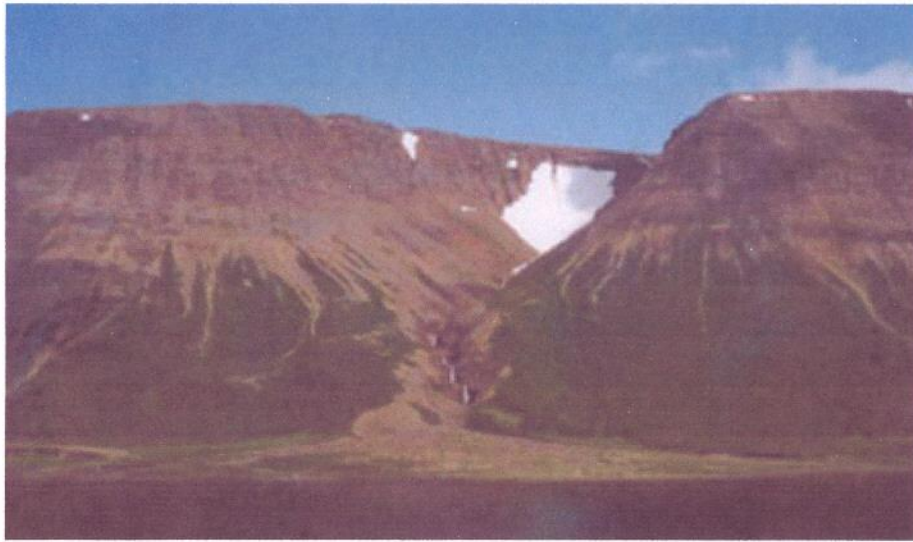
Figure 23: Overview of the valley cutting the Lambadalshlíð slope and associated large colluvium prograding in the fjord. The picture is taken towards the northeast.

Eastwards, the second sector presents a valley that deeply cut the slope (Fig. 21). In the lower part, the river flows in a canyon. The bowl-shaped valley presents steep walls, scree in the lower part and bedrock in the higher part. Quite a lot of snow is still present in mid-July. On the west side of the canyon, the topography is undulating.

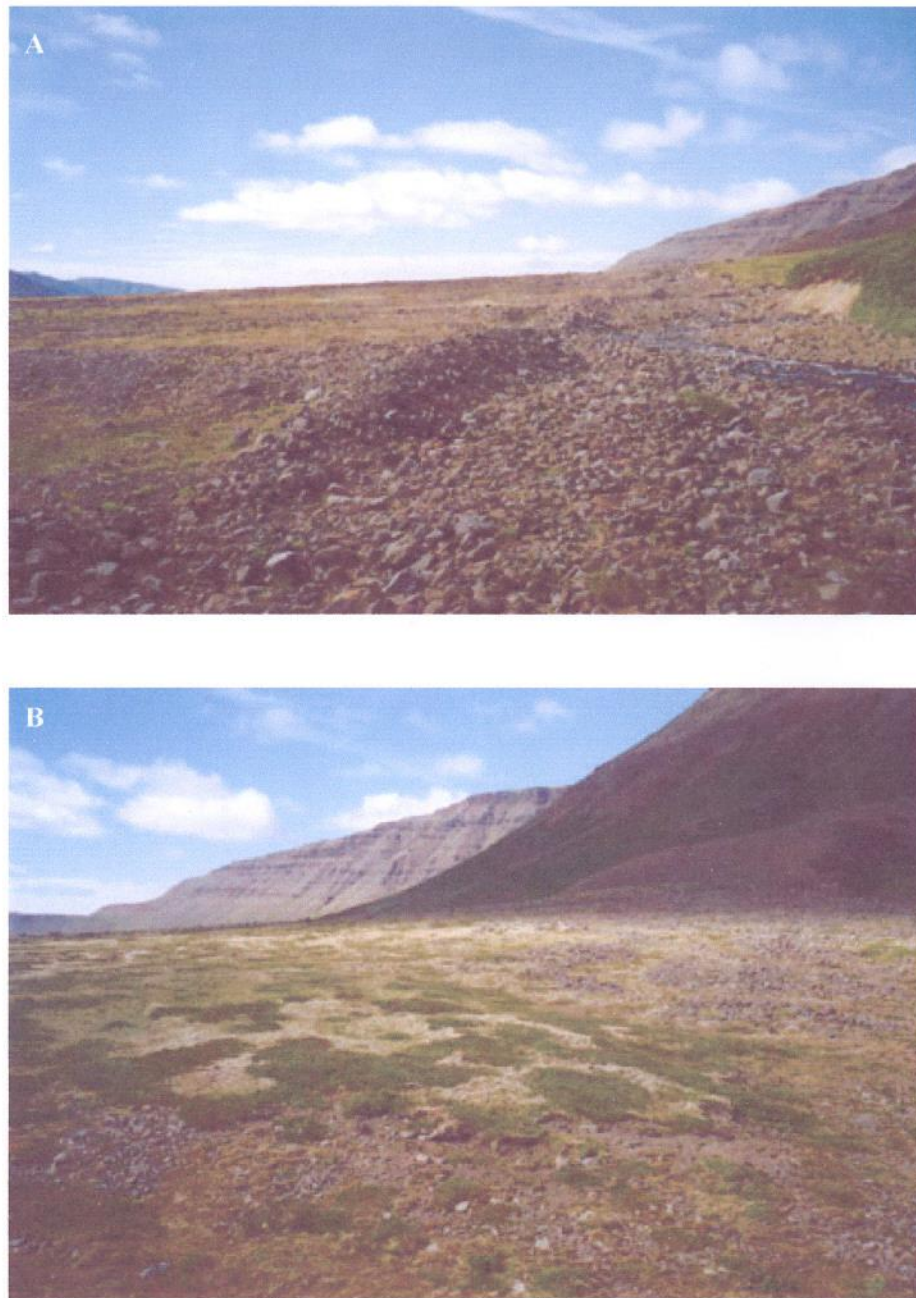
Figure 24: Different aspects of the large Valseyri colluvium. From the East to the West: (A) river along the western edge of the colluvium with levées and erosion from the slope. The picture is taken towards northwest; (B) Transition between an area with old and vegetated tracks of channels and levées (right) and a smooth and well a vegetated area (left). The picture is taken towards north-northwest.

The colluvium in Valseyri is very large and progrades far into the fjord with a very gently slope, forming a large half disc prograding in the fjord (Fig. 21). Some parts are vegetated and boulders are present on the surface. The more proximal part of the colluvium is covered by large stones and looks like a secondary lobe (Fig. 22D). The river flows along the eastern edge, eroding the material from the slope (Fig. 22A). Levées are deposited along the inner side of the river. Then towards the west, the colluvium surface is bumpy, presenting old and vegetated tracks of channels and levées with stones (on the right on Fig. 22B). The relief is fading out but is still obvious. No boulder is present. Then the colluvium is smooth and vegetated by mosses and herbs (on the left on Fig. 22B). No boulder and even no stone is visible. In the central part, some more recent channels form a web less dense than the previously described (Fig. 22C). Some of the channels go through the road all the way to the fjord. Stones are present on the levées and in the bottom of the channels. On the western half of the colluvium, first no channel is present but bushes and boulders are (Fig. 22D), and then in the outer part, channels with levées of stones occur again but vegetation returns the area and boulders are absent. Vegetation around consists of mosses, bushes and herbs. Boulders and stones are put on the surface. Some of the boulders are quite large (2 meters) and far on this very gentle slope.

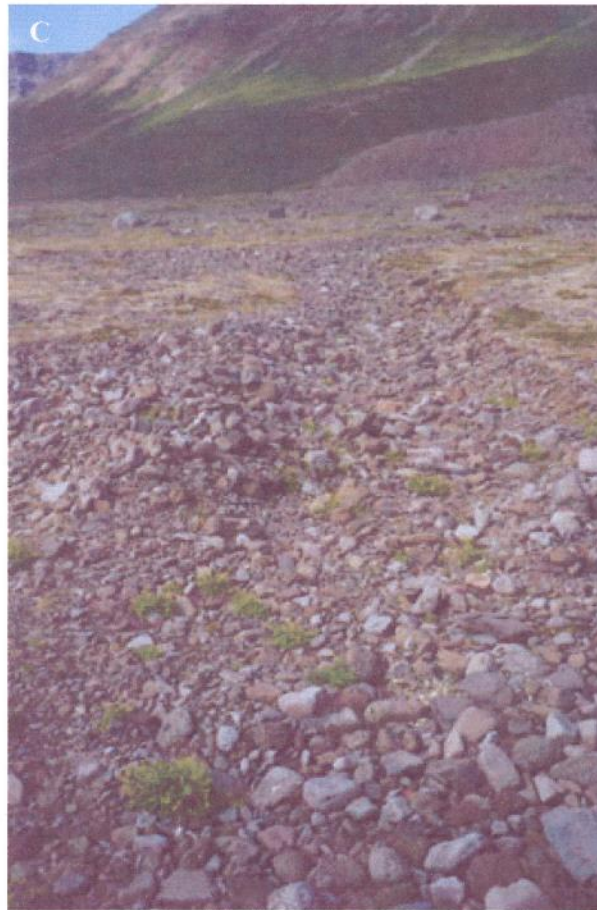
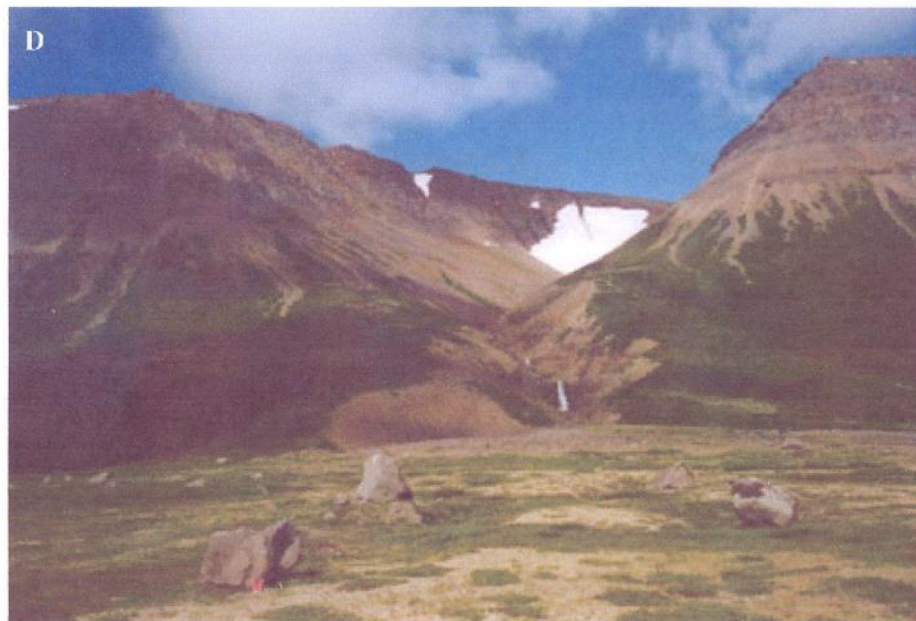
Figure 25, cont.: Different aspects of the large Valseyri colluvium. (C) Central part with a web of channels more recent but not as dense as on (B left). The picture is taken towards north; (D) Smooth and well vegetated area with large boulders. The notebook is 20 cm high. The picture is taken towards northeast.

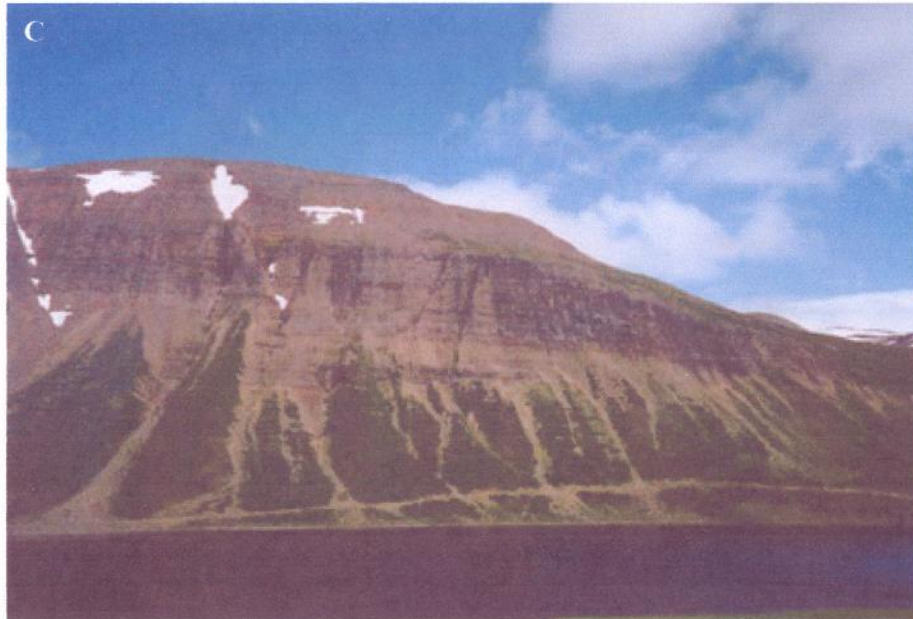
Figure 27, cont.: Overview of the third sector of the Lambadalshlíð slope, from the West (A) to the East (C). The channels get more and more frequent eastwards and are the widest centrally. The picture is taken towards northeast (A and C) and north-northeast (B).
